INSTRUMENTS AND SWITCHES

Instruments

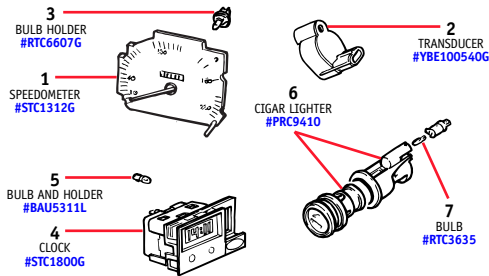
1	STC1312G	SPEEDOMETER, MPH, Genuine <i>Through 1995 model year</i>	1
2	YBE100540G	TRANSDUCER, speed, Genuine <i>Fitted to transfer box</i>	1
3	RTC6607G	BULB HOLDER, instruments, 1.12W, black body, Genuine	A/R
4	STC1800G	CLOCK ASSEMBLY, Genuine <i>Does not include hazard light switch</i>	1
5	BAU5311L	BULB HOLDER AND BULB, clock	1
6	PRC9410	CIGAR LIGHTER ASSEMBLY	2
7	RTC3635	BULB, 1.2W, cigar lighter	2

If your clock unit has failed, it is easily replaced with part #STC1800G (see 4), however, removing the old unit requires some specific steps as follows:

- Remove drinks tray
 - Remove ashtray by pushing spring clip down. Remove auxiliary switch panel, it snaps out.
 - Remove six screws holding tray. Three in each compartment where switch panel and ashtray were.
- Remove clock by releasing four tabs that hold the clock in place
 - To release the tabs, insert a thin strip of metal such as a feeler gauge at four places indicated in picture. **You will need to do all four at the same time.**
 - Slide clock out and disconnect electrical plugs.
 - Install new unit by connecting electrical plugs and snap back in place
 - Install drinks tray, ashtray and switch panel.

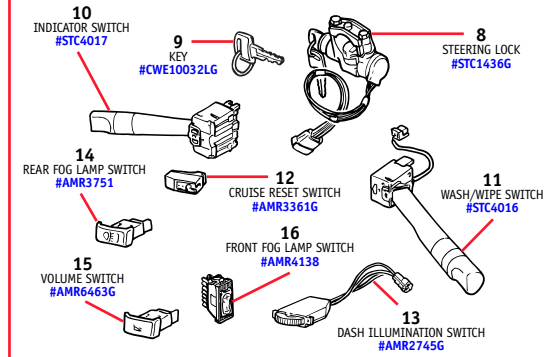
Fascia Switches

8	STC1436G	LOCK ASSY, steering, with ignition switch <i>Genuine, Automatic transmission</i>	1
	STC1435	IGNITION SWITCH/LOCK, D1 Manual Trans	1
	STC1746	IGNITION SWITCH, Electrical Part D1	1
9	CWE10032LG	KEY, blank, Genuine	A/R
		<i>Original style with rubber head</i>	
10	STC4017	SWITCH, turn indicator and headlamps	1
11	STC4016	SWITCH, wash/wipe, front	1
12	AMR3361G	SWITCH, cruise control, reset/cancel, Genuine	1
13	AMR2745G	SWITCH, rheostat, dash illumination, Genuine	1
14	AMR3751	SWITCH, rear fog lamp <i>Through (v) TA534103 and TA703236</i>	1
15	AMR6463G	SWITCH, volume control, down, Genuine <i>From (v) VA543814 and VA712445 on; can be fitted to earlier models</i>	1
16	AMR4138	SWITCH, front fog lamp, Genuine <i>From 1996 model year on</i>	1

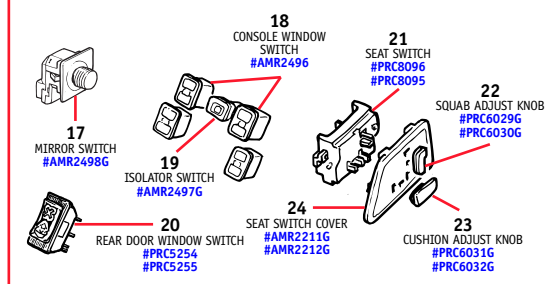
Window and Seat Switches

17	AMR2498G	SWITCH, door mirror, Genuine <i>Up to (v) VA745654</i>	1
18	AMR2496	SWITCH, window lift, console	4
19	AMR2497G	SWITCH, isolator, window lift, Genuine	1
20	PRC5254	SWITCH, window lift, rear door, RH	1
	PRC5255	SWITCH, window lift, rear door, LH	1
21	PRC8096	SWITCH ASSY, seat, non-memory, LH	1
	PRC8095	SWITCH ASSY, seat, non-memory, RH	1
22	PRC6029G	KNOB, switch, squab adjust, LH, Genuine	1
	PRC6030G	KNOB, switch, squab adjust, RH, Genuine	1
23	PRC6031G	KNOB, switch, cushion adjust, LH, Genuine	1
	PRC6032G	KNOB, switch, cushion adjust, RH, Genuine	1

24	AWR2211G	COVER, seat switch, LH, Genuine	1
	AWR2212G	COVER, seat switch, RH, Genuine	1

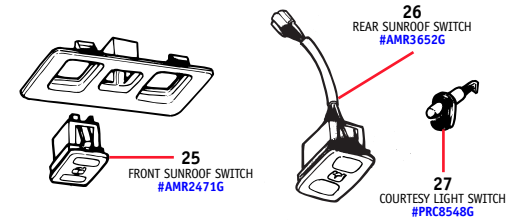
Sunroof and Courtesy Lamp Switches

25	AMR2471G	SWITCH, sunroof, front, Genuine	1
26	AMR3652G	SWITCH, sunroof, rear, Genuine	1
27	PRC8548G	SWITCH, door, courtesy lamp, Genuine	5
